Please accept the following as feedback from the Burlington Quarry Joint Agency Review Team (JART). Fully addressing each comment below will help expedite the potential for resolutions of the consolidated JART objections and individual agency objections. **Additional, new comments may be provided once a response has been prepared to the comments raised below and additional information provided**.

NEC Comment on behalf of JART (December 2020)	Applicant Response (June 2021)	NEC Response on behalf of JART
 Photo Methodology: Detailed methodology for photography was not provided. The following information is required: o camera lens o camera height o panorama production (i.e. photo overlap, angle of view) 	Section 3.0 (Methodology) has been updated explaining the camera specs and photo methodology. See updated report dated June 2021.	The detailed methodology is generally satisfactory, however, 180 degree panoramic photos are not ideal as they provide a distorted representation of the view in the field, for example, straight roads appear to bend behind the viewer. New photographs may be needed to the production of photo simulations to ensure the greatest possible accuracy is achieved.

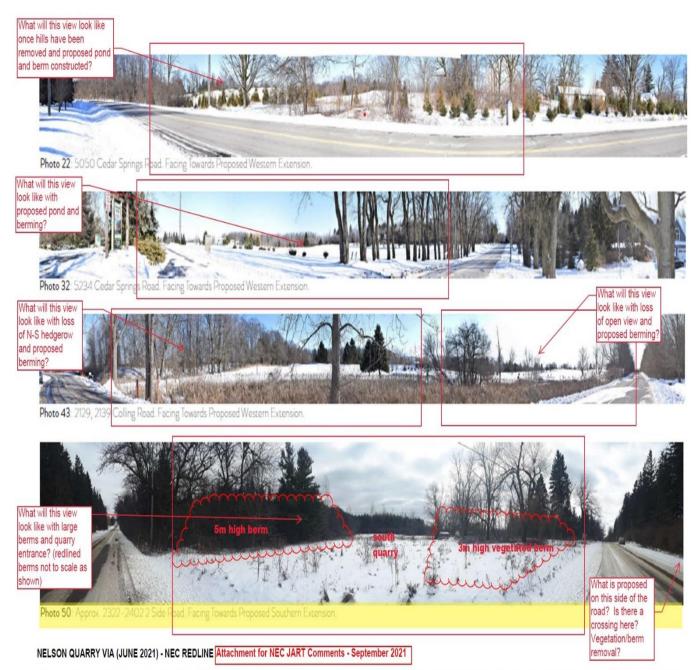
These are the views of concern requiring further study. Photo simulations are required. Due to distortion in the panoramas, new base photography may be required for these views to ensure accuracy in the photo simulations.

View from Colling Road southwest across wetland towards golf course (Photo 43 right side - shown below with JART mark-up) – What is the impact to open landscape character? What is the visual impact associated with constructing a berm here? How will the berm be screened from view? 	
 View from No. 2 Sideroad south to quarry entrance (Photo 50 - shown below with JART mark-up) – What is the visual impact of constructing such large berms so close to the road? How will proposed vegetation mitigate the impacts? What will the large opening between berms look like? Does it need to be that large? What visual impacts will be associated with a crossing? What will the north side of the road look like? 	
Note: Some photos may need to be re-shot or cropped for use in the production of photo simulations to ensure technical accuracy. A terms of reference outlining the detailed methodology for the production of photo simulations will be required for NEC review prior to a re-submission. NEC has prepared a redline of key photos to accompany this request for photo simulations as attached. Refer to the redline for areas of interest to target in the photo simulations.

There are a few technical issues with the cross sections provided in the VIA:	
 The accuracy of the Section H sight line is not reliable as shown. A section break has been used to fit the long section onto the page but it does not appear to have been similarly applied to the sight line. Please demonstrate that the berm is effective at blocking sight lines into the quarry without a break in the section line. 	
 Section C and Section D are not correctly located on the key plan, and the road in Section D is mislabelled as Cedar Springs Road but appears to be No. 2 Sideroad. 	
 Section E, F, G, H do not sufficiently illustrate proposed changes to the subject lands, which include landform alteration and the construction of a pond. 	
The VIA describes future rehabilitation as including the removal of visual and noise berms and reestablishment of views into the quarried lands with a goal to 'enhance the existing open landscape character of the area' (see Section 8.0). Further study is required to demonstrate how this will be achieved. Please provide photo simulations showing proposed rehabilitation conditions for views of concern (Photo 22, 32, 43, and 50 - shown below with JART mark-up).
